PLAT OF THE RETRACEMENT AND REMONUMENTATION OF H.E.S.-207, SECTION 9 A PORTION OF THE LINCOLN NATIONAL FOREST PROPERTY LINE

SITUATED IN T. 17 S., R. 11 E., NEW MEXICO PRINCIPAL MERIDIAN, NEW MEXICO

TRANSCRIPT OF FIELD NOTES BOOK 17

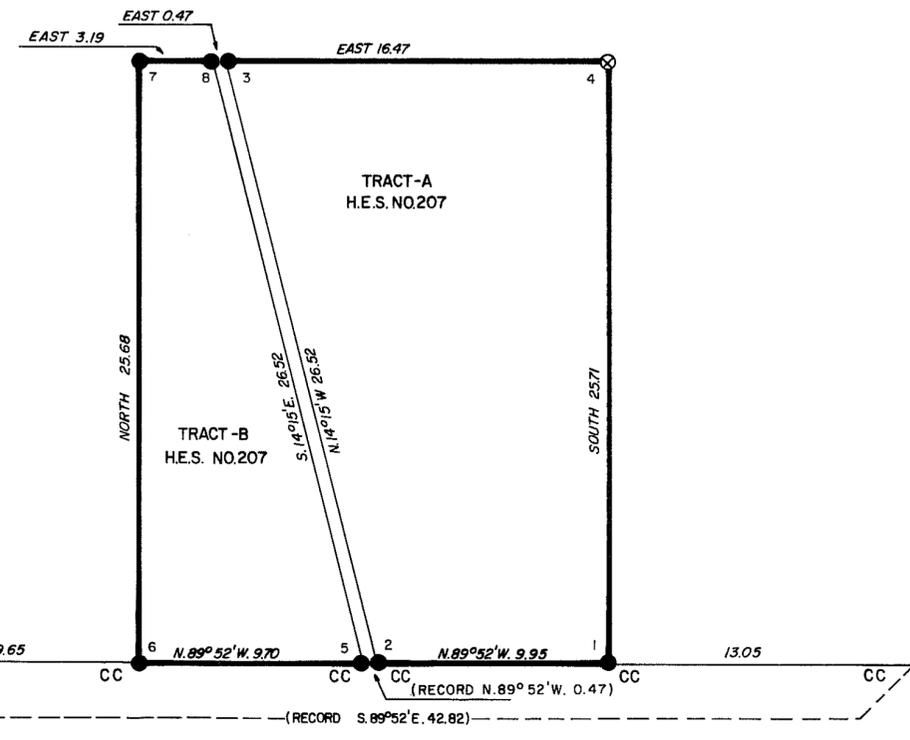
SEC. 9

This plat represents a record of the retracement and remonumentation of H.E.S.-207 located in Section 9, T17S, R11E, New Mexico Principal Meridian, which constitutes a portion of the property boundary of the Lincoln National Forest.
